## IND: Agartala City Urban Development Project – Revival and Restoration of Ujjayanta Palace Complex in Agartala City PART B

**HERITAGE IMPACT ASSESSMENT REPORT  
OF  
REVIVAL AND RESTORATION OF UJJAYANTA PALACE COMPLEX  
DOCUMENT NUMBER: TCE.10918A-CH-2008-ER-01**

**Document Description:** HERITAGE IMPACT ASSESSMENT OF REVIVAL AND RESTORATION OF UJJAYANTA PALACE COMPLEX

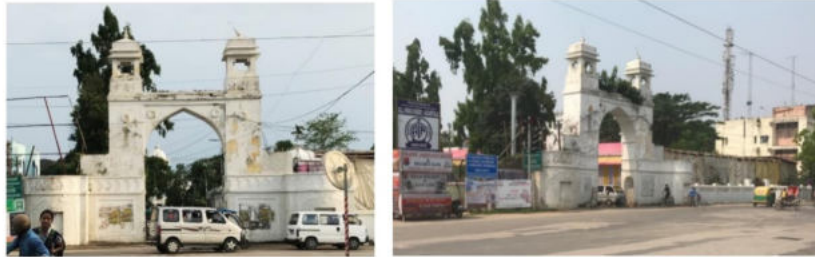
- Due to vegetation growth, the aesthetics of the gate has been disturbed.
- Surface cracks have developed on the structure due to lack of maintenance.
- Overhead wires and sticking of bills have also contributed to the poor aesthetics of the structure.

FIGURE 14 EXISTING CONDITION OF THE NORTH GATE

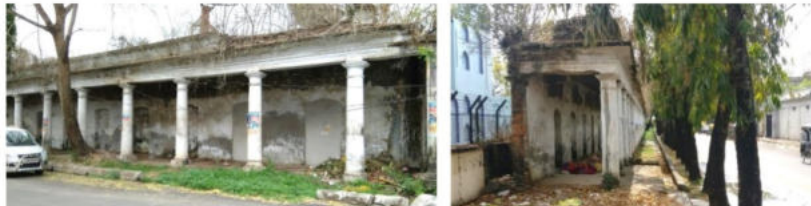
The Astabal is located at the rear portion of the palace building and can be accessed through the 6m wide road leading to the palace complex from the North Gate. The total stretch is 130m long and 5m wide. The structure is presently in a redundant and poor condition.

- Surface cracks have developed on the walls and ceiling and reinforcement has been exposed.
- The aesthetics of the structure has been compromised due to wild vegetation growth, overhead wires and sticking of bills as seen in the pictures below.
- The existing 6m road lacks in pedestrian facilities and is occasionally encroached by non-designated on street parking.

FIGURE 15 CRACKED CEILING AND WILD VEGETATION GROWTH ON THE EXISTING ASTABAL STRUCTURE

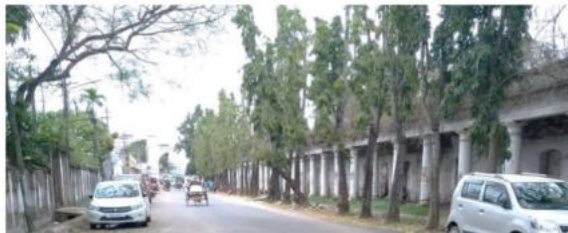
FIGURE 16 EXISTING STREETSCAPE IN FRONT OF THE ASTABAL STRUCTURE

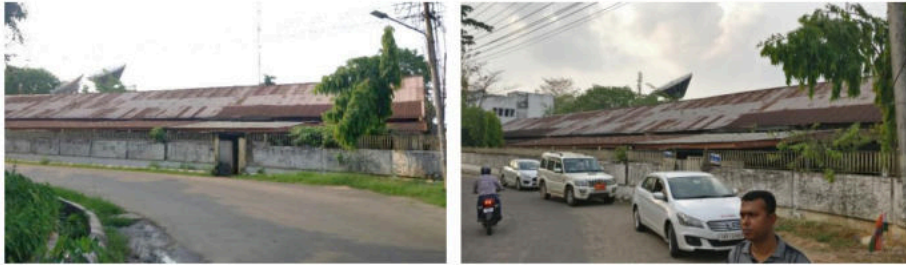
The site proposed for the food court presently houses an old structure which is to be demolished. The plot dimensions are 60m x18m as per available data. It can be accessed through the 6m wide road and has a boundary wall on the periphery. The entire stretch of the road as mentioned in the previous sections lacks pedestrian facilities.

FIGURE 17 FRONT VIEW OF THE SITE PROPOSED FOR FOOD COURT

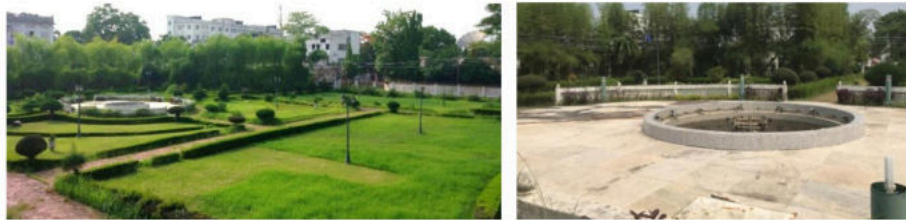
- The existing fountain is presently dysfunctional and needs repair.
- Overgrowth of wild vegetation on the pathways and lawns.
- The garden lacks shaded seating and furniture to make it usable for public use.
- The pathways are in a dilapidated state.

FIGURE 18 VIEW OF THE REAR GARDEN SHOWING THE EXISTING FOUNTAIN

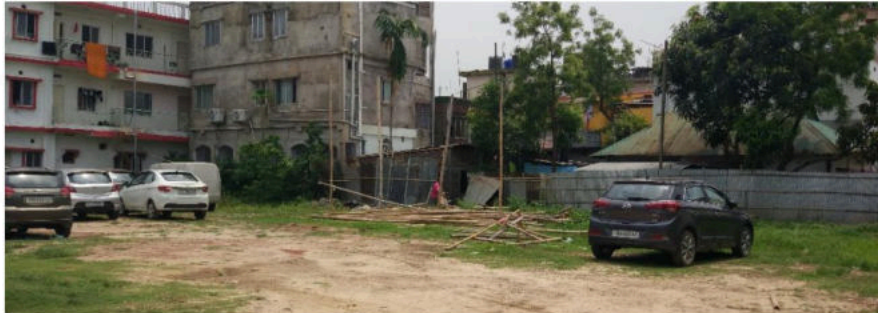
The eastern lake in front of the palace can be accessed by the adjoining road. Approximate width available for development of the promenade is 3.5m which includes an existing 2m wide pathway. The existing site acts as a temporary parking space and lacks in designated parking bays.

FIGURE 19 EXISTING SITE FOR VISITOR PARKING

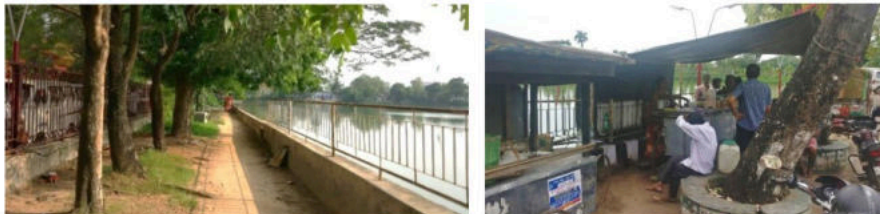
- Irresponsible disposal of solid waste in the edges of lake.
- The existing railing is in a dilapidated condition and needs refurbishment.
- The existing street furniture is not adequate in numbers and is not in a proper condition.
- The footpath has been encroached by the local vendor shops.

FIGURE 20 EXISTING CONDITION OF THE EASTERN LAKE EDGE SHOWING THE DILAPIDATED FOOTPATH AND VENDOR ENCROACHMENT

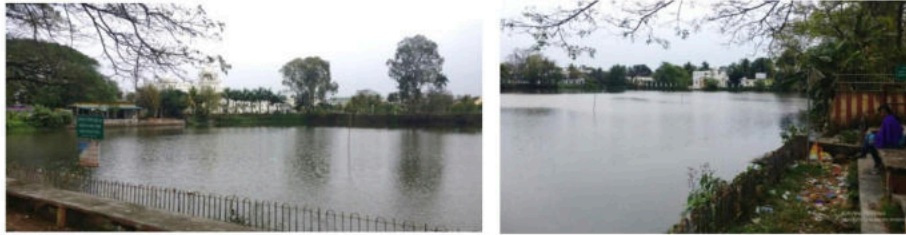
- Irresponsible waste disposal can be seen near the western lake as well.
- The existing railing and street furniture are not in adequate condition.
- The overgrowth of wild vegetation can be seen around the lake.
- The access points to the lake edges are not clearly defined.

FIGURE 21 VIEW OF THE EXISTING WESTERN LAKE EDGE

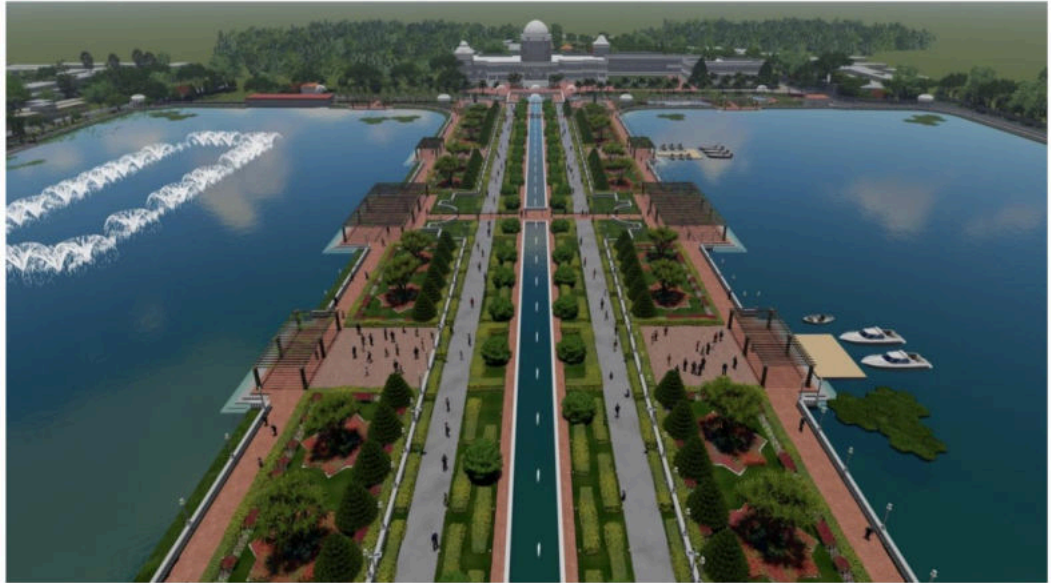
FIGURE 24 PROPOSED VIEW OF THE FRONT GARDEN

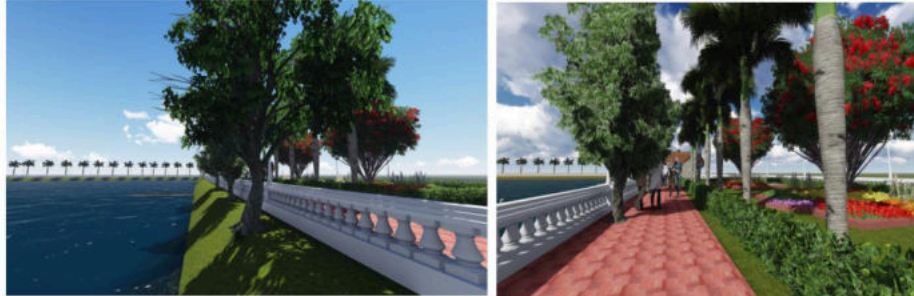
FIGURE 26 GREEN EMBANKMENT ALONG THE POND EDGES BOUNDED WITH HERITAGE RAILINGS AND ADJACENT PEDESTRAIN PATHWAY

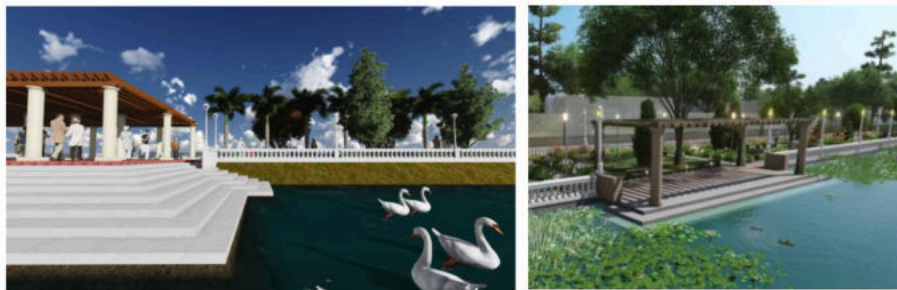
FIGURE 25 PROPOSED PERGOLA ABOVE STEPPED EMBANKMENT

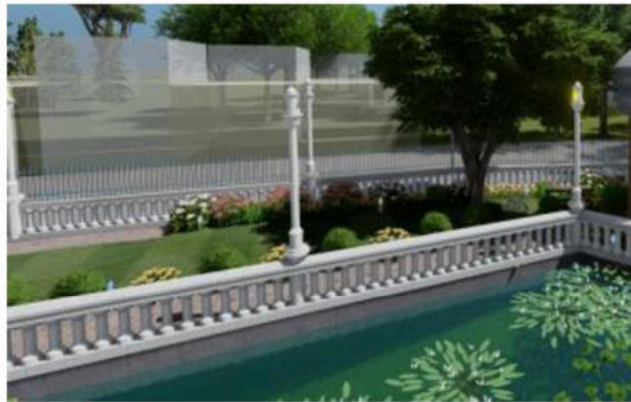
FIGURE 28 NEW RAILINGS CONSTRUCTED KEEPING PARITY WITH THE HERITAGE ONES

- Restoration of existing heritage structures like Chhatris with patchwork, plastering, painting, reinstating broken shapes, decorative lighting and cleaning of the statues.
- Construction of new railing along the water bodies keeping similarity with existing heritage railing.

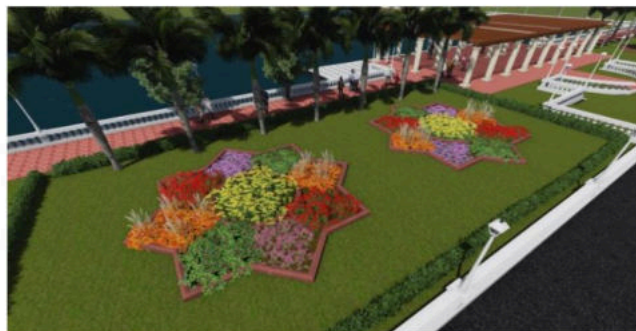
FIGURE 29 LANDSCAPED GARDEN

- Attractive lighting and illumination of important feature of garden
- Irrigation system to cover all the softscape areas
- Garden furniture, like seating dustbin etc.
- Required signage.
- Modification of drainage network for entire site with suitable drain cover
